NMA REPORT #R-208

## LESSONS FROM MAJOR OFFSHORE SUPPLY VESSEL ACCIDENTS

### INCIDENT #1 – COLLISION OSV BASS RIVER and OSV C-CAPTAIN

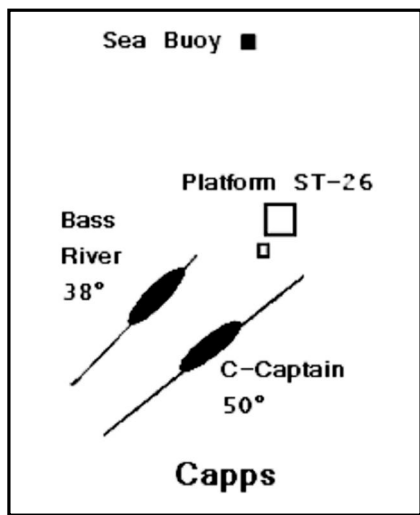
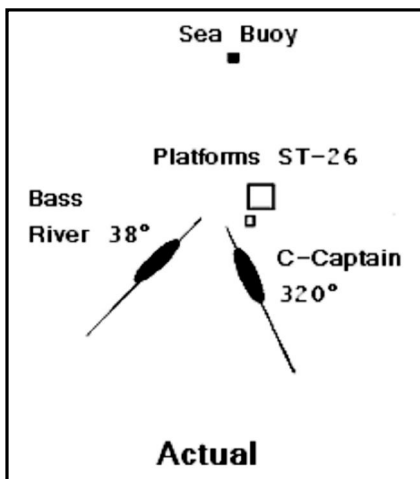
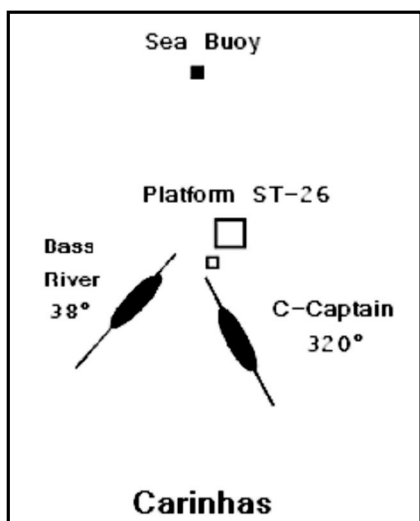
Figure 1  
(Representative only)

The C-CAPTAIN was sailing on a north-northwesterly course of 310° and then 318-320° as it made steady progress to the sea buoy. The BASS RIVER had an easterly heading of 050° and was making good 037-38° over the ground while **heading for Exxon's Grand Isle base to the east of Belle Pass. Inexplicably, Capps thought the C-CAPTAIN was also on an easterly course** (approximately 10° off his) and to the south of his vessel. He testified he was aware the C-CAPTAIN was going into Belle Pass, and he even mentioned this at the beginning of his second conversation with the C-CAPTAIN. Since Belle Pass was to the north of his vessel, and since he thought

the C-CAPTAIN was on an almost parallel course south of BASS RIVER, he was under the erroneous impression the C-CAPTAIN would be turning left, or to port (pp. 70-71) (contrary to what he was specifically told by Carinhas in their first conversation), which would presumably take it across the generally easterly path of the BASS RIVER. However, Capps' appreciation of the situation was incorrect, as reflected in Figure 1 below which depicts the situation actually presented to the mariners, along with each mariner's individual appreciation of the situation.
