NMA REPORT #R-293-B, Revision 8

REQUEST FOR RULEMAKING TO ADDRESS OVERHEAD CLEARANCE ACCIDENTS

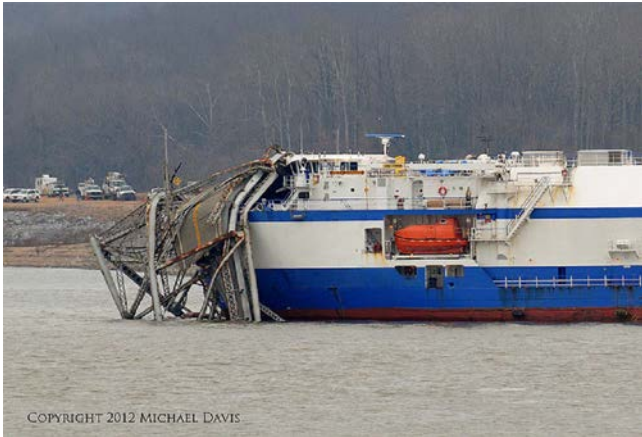
A main span of the bridge collapsed after being struck by the cargo vessel M/V Delta Mariner on January 26, 2012. At least four vehicles were reported to be on the bridge near the time of the collapse. One pickup truck stopped about 5 feet from the edge of the missing section; the driver reported that two cars had stopped directly behind him, and he saw another car on the opposite side of the missing section. No injuries were reported.

The U.S. Coast Guard reported on Jan. 27 that the Delta Mariner hit the bridge when it tried to pass through what is known as the recreational channel, which has a lower clearance, instead of the shipping channel, which the vessel normally used. Reports indicate that some of the bridge's navigational lighting was inoperative at the time of the incident. Paducah television station WPSD-TV reported earlier in the week that the bridge was to be reduced to one lane on Jan. 27 for a Kentucky Transportation Cabinet crew to repair the lights. KYTC spokesman Keith Todd stated that the lights facing the MV Delta Mariner were operational, and that the Coast Guard had made the lighting situation known to vessels operating on the waterway.

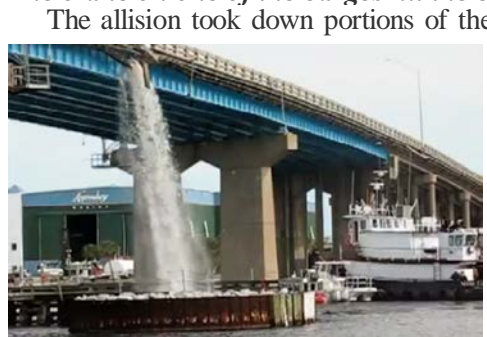
The crane on one of the barges hit the bridge.

The collision took down portions of the bridge’s concrete guardrail and broke a water main running underneath the eastbound sidewalk on the bridge. Concrete and water from the pipe cascaded into the water below. Fortunately no one was hurt and no vehicles crossing the bridge were damaged, but the bridge was closed immediately to vehicular and pedestrian traffic.

When the crane struck the bridge, the forward end of the barge reportedly lifted out of the water but kept moving forward for about 15 seconds as the crane tipped back so far that it touched the barge behind it.

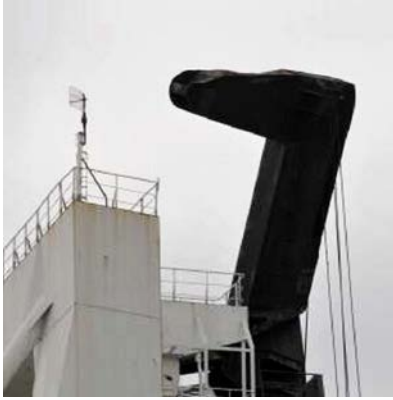
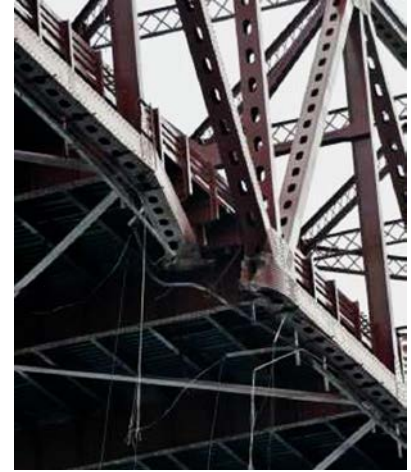
of the St. Johns River. The stern ramp of the ship was in an elevated position when it struck the Mathews Bridge, which connects downtown Jacksonville to the Arlington area. The hit tore out a main girder on the bridge.
