MARINE ACCIDENT INVESTIGATION BRANCH

Bridge Watchkeeping Safety Study

Safety Study 1/2004
July 2004

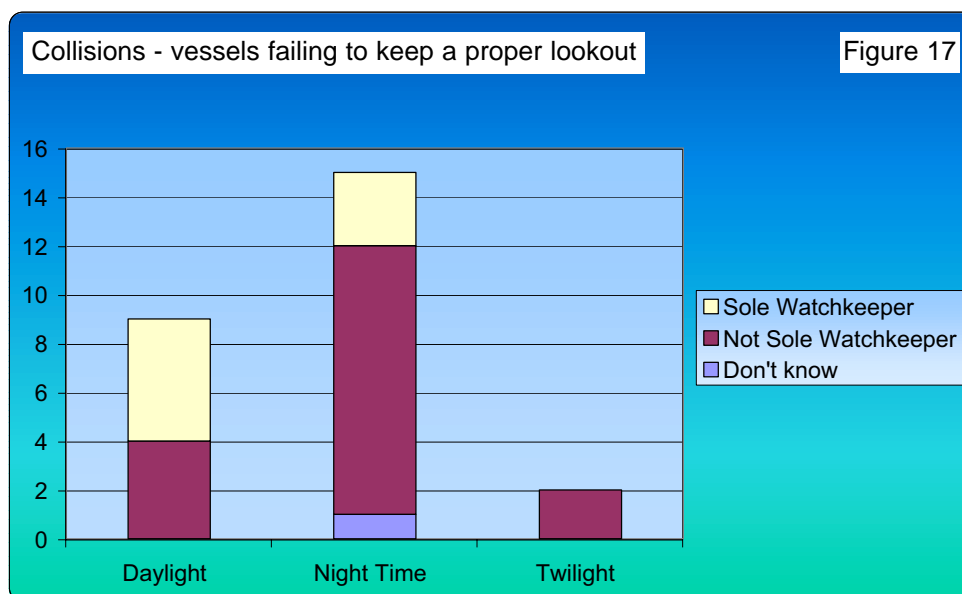
Despite this requirement, **Figure 17** shows that at least three of the fifteen vessels which failed to keep a proper lookout at night had lone watchkeepers on the bridge. Of the nine vessels not maintaining a proper lookout by day, five had sole watchkeepers; three of these were in an area of high traffic density, and one was in poor visibility. It follows that seven of the eight vessels with sole watchkeepers involved in collision, in which poor lookout was deemed to be a contributing factor, representing nearly one-third of the vessels in this category, were in contravention of this aspect of STCW as well as the collision regulations.

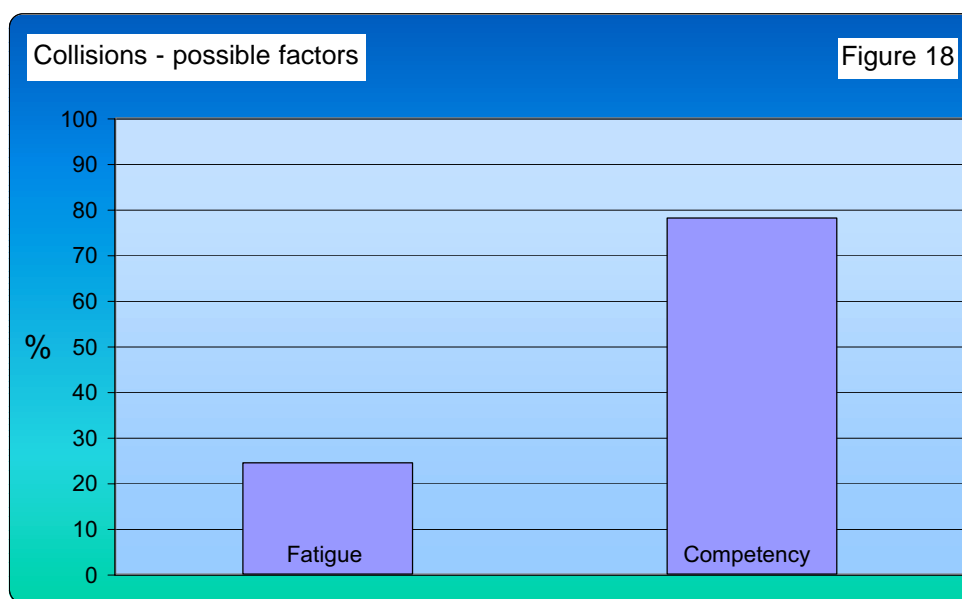
It is also evident, however, that the bridges of 19 vessels were manned in accordance with the provisions for lookout, as set out in STCW 95, yet still failed to maintain a proper lookout. There are several possible reasons for this, and **Figure 18** illustrates that competency may be more contributory in this respect than fatigue. Importantly, however, in the MAIB's experience, poor visual lookout can also be linked to the poor employment of ratings on the bridge. On many ships, although ratings are usually available to provide an additional lookout, they are rarely used for this purpose during daylight. A common view encountered is that ratings are generally of little value on the bridge and are of more use working on the deck. Additionally, although many ships use an additional lookout on the bridge at night, his presence is often seen as a token gesture aimed at meeting regulatory requirements. There is evidence that some OOWs do not even speak to the rating on watch with them, particularly when differing nationalities are involved.

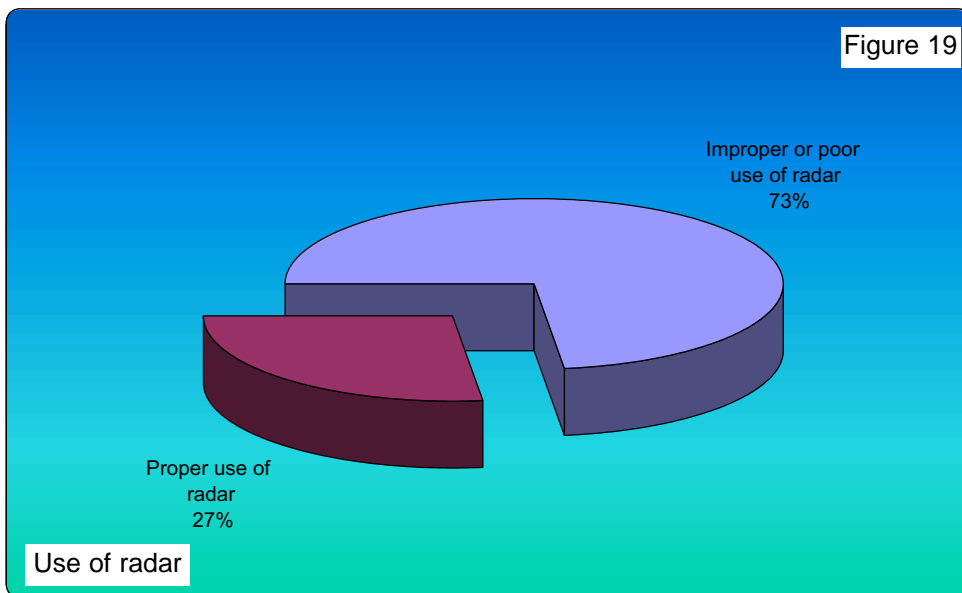
As technology has advanced with regard to radar and ARPA, and the number of crew on vessels has decreased in parallel with increased automation, it is inevitable that bridge watchkeeping practices have changed in recent years. OOWs place more reliance on radar and ARPA to maintain a lookout, and to assess the risk of collision. Indeed, many newer vessels are not even equipped with a gyro pelorus on the bridge with which to take a visual bearing. It is therefore disturbing that the OOWs on 73% of the vessels involved in collision (**Figure 19**) potentially contravened Rules 7(b) or 7(c), which state:
