Crew Fatigue Caused 2016 Grounding of Kirby Tug Nathan E. Stewart in British Columbia, Report Says

June 6, 2018 by gCaptain

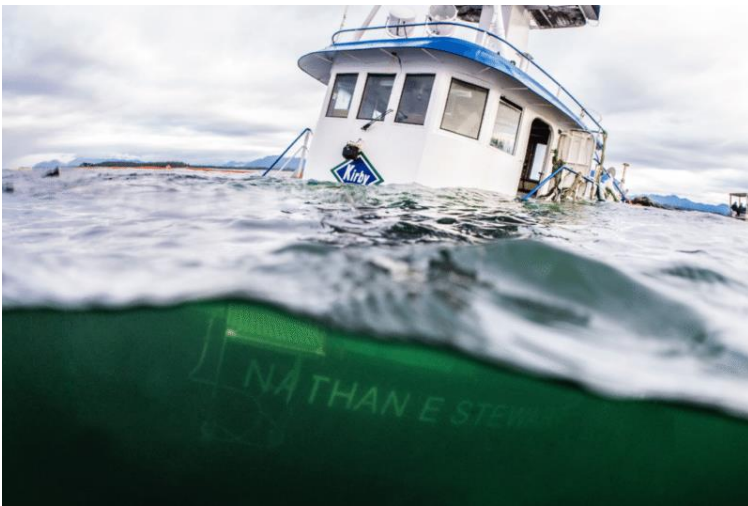
The wreck of the Nathan E. Stewart near Bella Bella, British Columbia, October 13, 2016.

The investigation revealed that the second mate, who was alone on the bridge at the time of the accident, had fallen asleep after working a 6-on, 6-off shift schedule for at least two days leading up to the grounding.

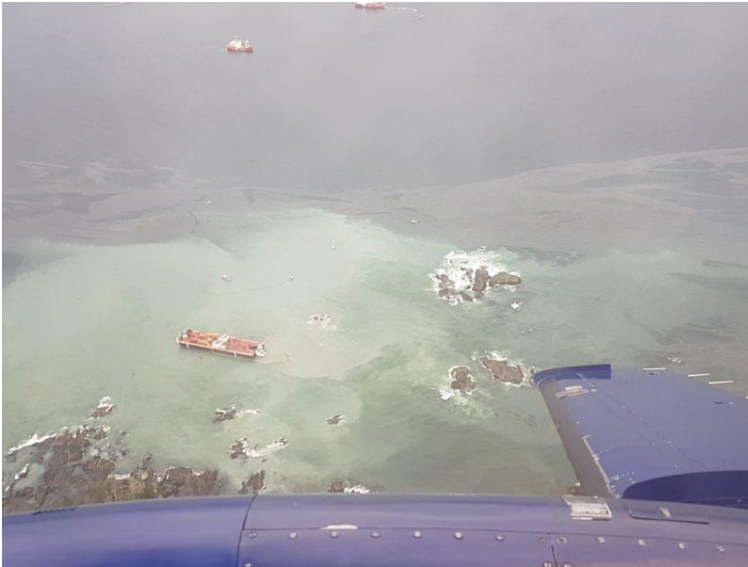
The Nathan E. Stewart aground near Bella Bella, British Columbia, October 13, 2016.

The investigation determined that the second mate who, contrary to Canadian regulations, was keeping watch alone on the bridge at the time of the accident, had fallen asleep and missed a planned course change.

First, it is recommending that Transport Canada require that watchkeepers receive mandatory education and awareness training to help identify and prevent the risks of fatigue.

Second, it is also recommending that vessel owners implement comprehensive fatigue-management plans, tailored specifically for their individual operations.
